**DESTROYER ENGINEERED OPERATING CYCLE
(DDEOC)**

DDG-37 CLASS

MAIN PROPULSION BOILERS

REVIEW OF EXPERIENCE

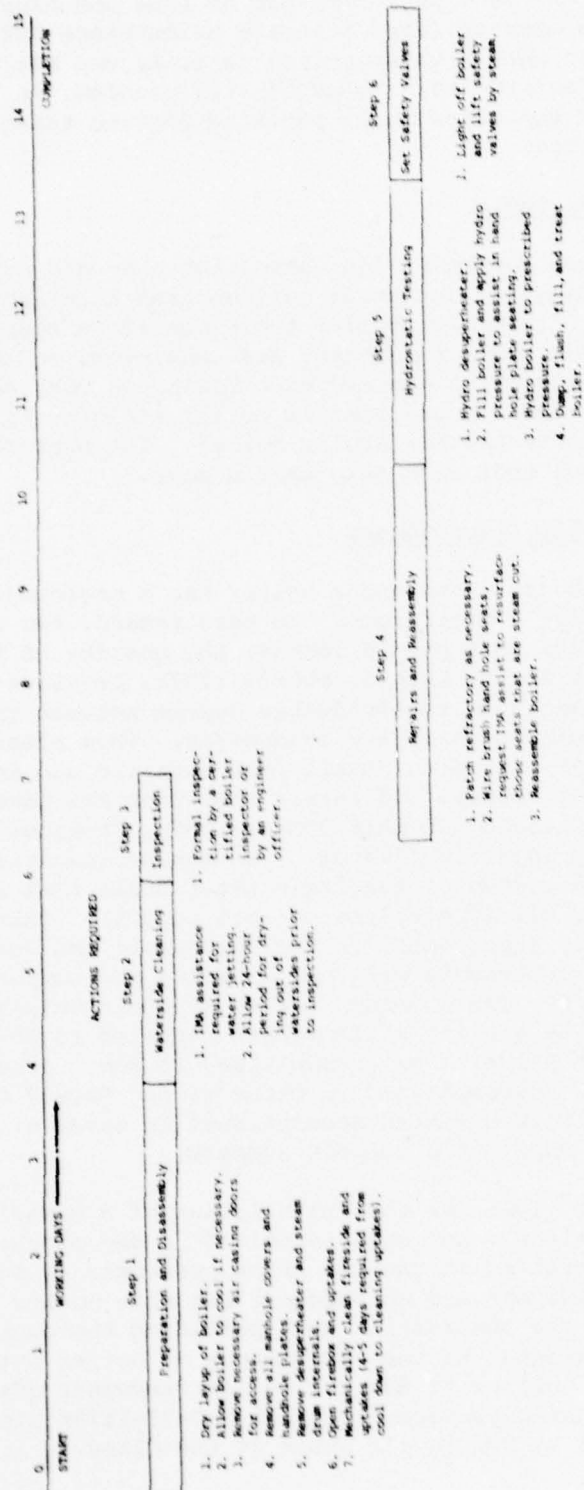
Figure 3-1. TYPICAL DRY-37 CLASS BOILER WATERSIDE AND FIREBOX CLEANING

Table 3-2 lists some of the parts replaced during waterside and fireside maintenance; Figure 3-1 shows the steps, man-hours, and calendar time normally required. Figure 3-1, an estimate of the action necessary to conduct waterside and fireside maintenance on one DDG-37 Class boiler, was formulated from MDS data and interviews with cognizant technical personnel.

NOTE: Approximately 40% manhours required to clean watersides and fireboxes on one boiler.

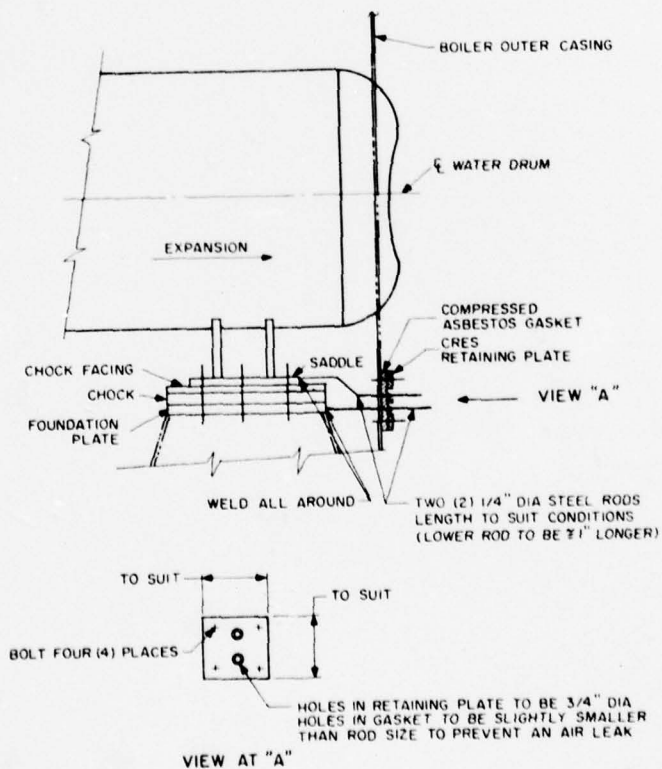
Figure D-1. SLIDING SADDLE MOVEMENT INDICATOR

Figure D-1 is a reproduction of Figure 9-2 found in Chapter 9 of NAVSEA 0951-LP-031-8010, Repair and Overhaul, Main Boiler, 1200 psi Steam Propulsion Plant. This indicator will provide a positive indication of sliding foot movement.

- Main steam valves should be overhauled only if they exhibit signs of seal ring leakage or steam leakage past the seat.
- A sliding foot movement indicator should be installed on each sliding foot during BOH. An investigation into the use of a non-lubricated foot is also recommended.

Boiler Sliding Feet	Install a sliding foot movement indicator as shown in Figure 9-2 of NAVSHIPS 0951-LP-011-R010.
B. SHIPALTS	
Refractory	Accomplish ShipAlt DDG-37-11120, Install Shock Hardened Brickwork.
Feedwater Quality Improvement	Accomplish the following ShipAlts: <ul style="list-style-type: none"> DDG-37-1207K, Install Ion Exchanger in Feedwater Line DDG-37-1056K, Install Morpholine Injection System DDG-37-1175K, Install Dissolved Oxygen Analyzer
Air Casings	Accomplish ShipAlt DDG-37-0357K, Boiler Outer Casing Replacement, on the FW boiler equipped ships.
Economizers	Accomplish ShipAlt DDG-37-1030K, Economizer Modifications, on the FW boiler equipped ships.
Burners	Accomplish ShipAlt DDG-37-1069K, Vented Plunger Burner Installation. Accomplish the following fuel oil related ShipAlts <ul style="list-style-type: none"> DDG-37-0116D, inspect and modify fuel oil burner leads DDG-37-0161D, modify boiler front DDG-37-1085K, install Marotta FOXCVs
